# Manhole Inspection Summary

Manhole # S55O\_\_009MH

Insp Date: **5/27/08 3:18 PM**

**Location** Address: **rear 3513 odonnell st**

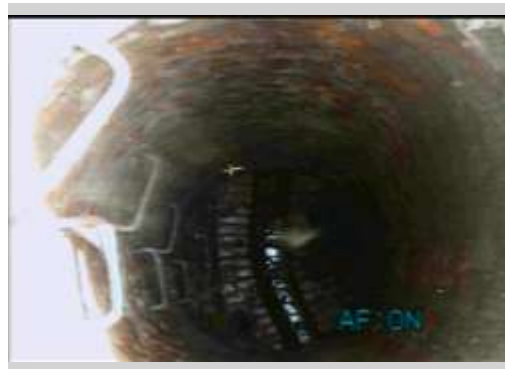
Top View

top view & steps

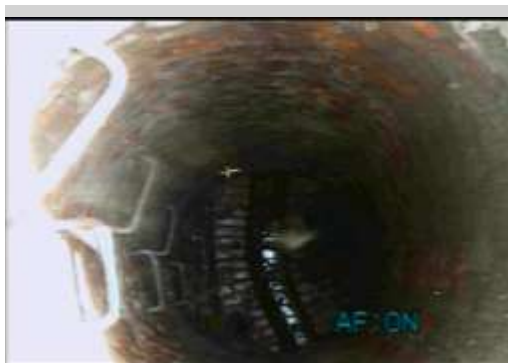
Defect 3

**Steps** Count: **6** Missing: **0** ☒ **Corroded**

steps

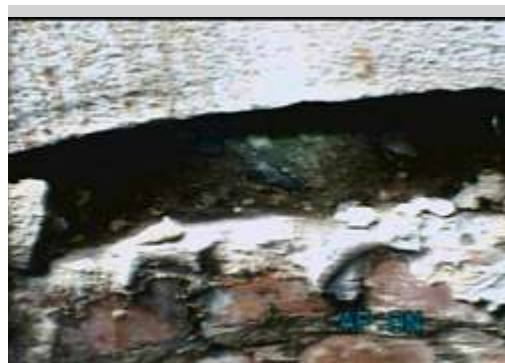
Defect 2

Condition: ☐ Sound ☐ Cracked ☐ Root Intrusion ☒ **Loose Brick** ☒ **Deteriorated**

frame adj; chimney loose bricks and deteriorated

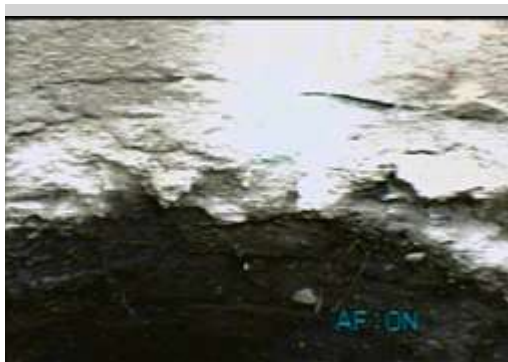
Defect 1

**Frame** Offset: **2** (in.) Condition: ☒ Sound ☐ Cracked ☐ Leaks

offset

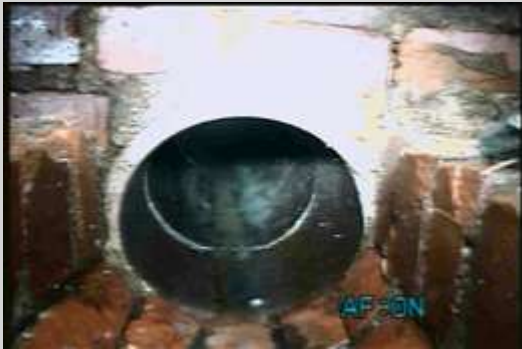
12 O'Clock Outflow

8 in. Circular Gravity Sewer  
Pipe Out @ 12 O'Clock

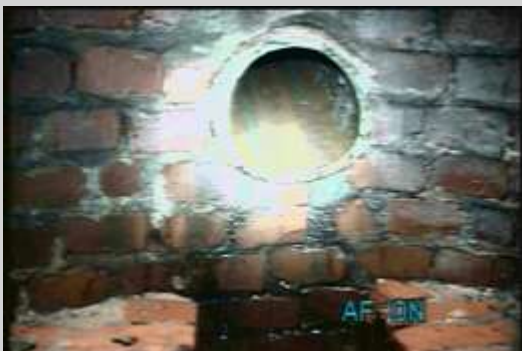
6 O'Clock Inflow

not a drop has only a blank wall below
